Experimental and analytical investigation of dynamic crack patterns in automotive windshield sheets subjected to low velocity impact

P. Shojaei Shahmirzadi, H. Saeidi Googarchin*

Automotive Fluids and Structures Analysis Research Laboratory, School of Automotive Engineering, Iran University of Science and Technology, Tehran 16846-13114, Iran

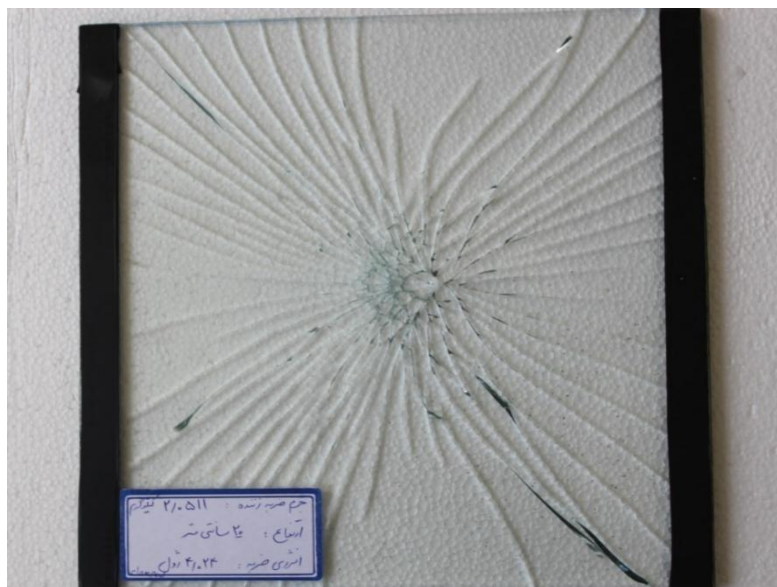
Fig6. specimen after test code D-B-T-2

Laminated glass specimen after test code D-B-T-2 is shown in Fig.6

Like test code D-B-T-1, no circumferential crack is observed at the specimen. The results of this test are akin to the test code D-B-T-1, just 2 differences are observed:

There are 62 radial cracks which is five number less than test code D-B-T-1.

The damage region at the center of specimen in test code D-B-T-2 is a bit larger than the counterpart region in test code D-B-T-1.

Indeed, some part of failure mode has been transformed to powdering failure mode.
