Study of the effect on manufacturing parameters on the fatigue behavior of aluminum engine mounting bracket

Hossein Khalajzadeh¹, Seyed Vahid Hosseini^{*1}, Alireza Shaterzadeh¹

¹Faculty of Mechanical Engineering, Shahrood University of Technology, Shahrood, Iran.

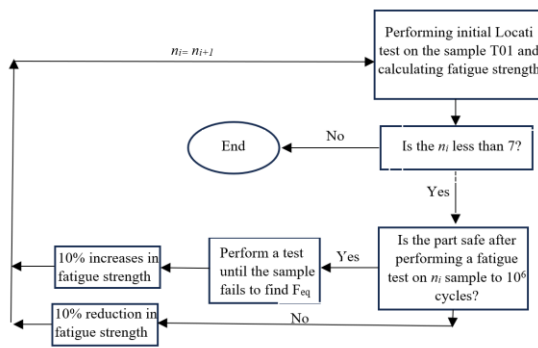
Figure 2. Flowchart of staircase and Locati test.

In the staircase test [23], the failure force obtained from the primary Locati test is applied to the piece up to $N_{ref} = 10^6$ cycles. The possible state of the piece under test will be in two ways:

a) If the part remains healthy and without any defects until the end of the test, the secondary test of Locati is repeated on the part with an increase of 10% force up to 10^6 cycles and this process continues until the failure of the part; for the next

piece, the above steps are repeated with a 10% force increase up to 10^6 cycles.

b) If a crack or fracture is observed in the part during the test, the staircase test is stopped and the next part is tested with a 10% reduction in force and repeating the above process.

In Figure 2 the steps of staircase and Locati test presented.

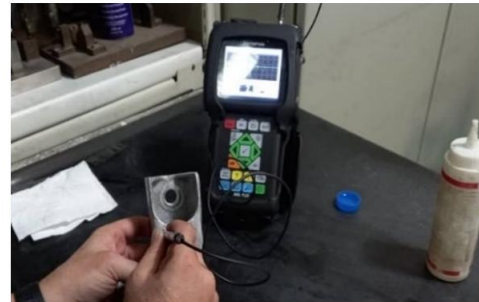
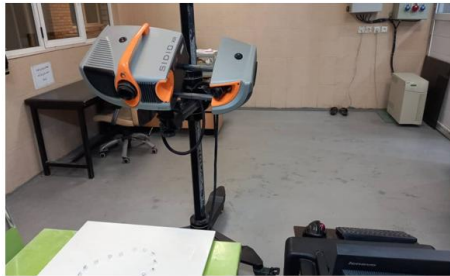
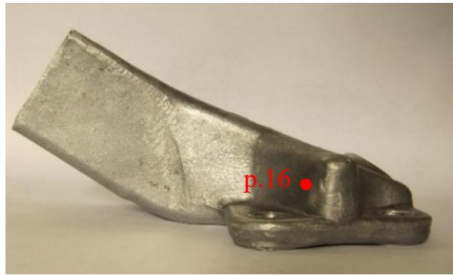
Figure 8. a) Ultrasonic thickness measurement. b) The graph obtained from the thickness measurement results of the prototype. c) Location of point 16 (Minimum thickness).

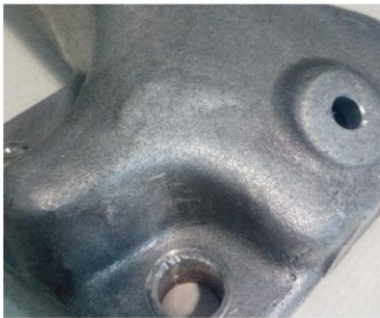
Figure 11. a) Identification of the crack in the front area of the primary sample. b) Removal of the crack in the front area of the modified sample. c) Appearance of a crack in the end area of the modified sample.

The reinforcement of the connection area of the base to the wall in the modified sample has led to the removal of the crack in this area. In order to make a more detailed investigation, after the completion of the fatigue test, a comparison of the primary and secondary samples was made by conducting a penetrating liquid test. Also, after fixing the manufacturing parameters to cause the cracks in the part, by repeating the high-cycle fatigue test on the modified sample, the crack moved from the connection area of the base to the wall to the end area of the part, as shown in Figure 11. This means that similar to the finite element results in the modified sample, the most critical region is located at point A. Table 9 shows the improvement of the modified sample respected to primary sample. As observed, the resistance of modified sample increased by 7% and scatter of fatigue results has decreased by 14%.
